**TN Tatem Middle School**  
**Indoor Air Quality Assessment September 2016**

Completed by Island Air Quality Services  
P.O. Box SN139  
Southampton SNBX  
Bermuda

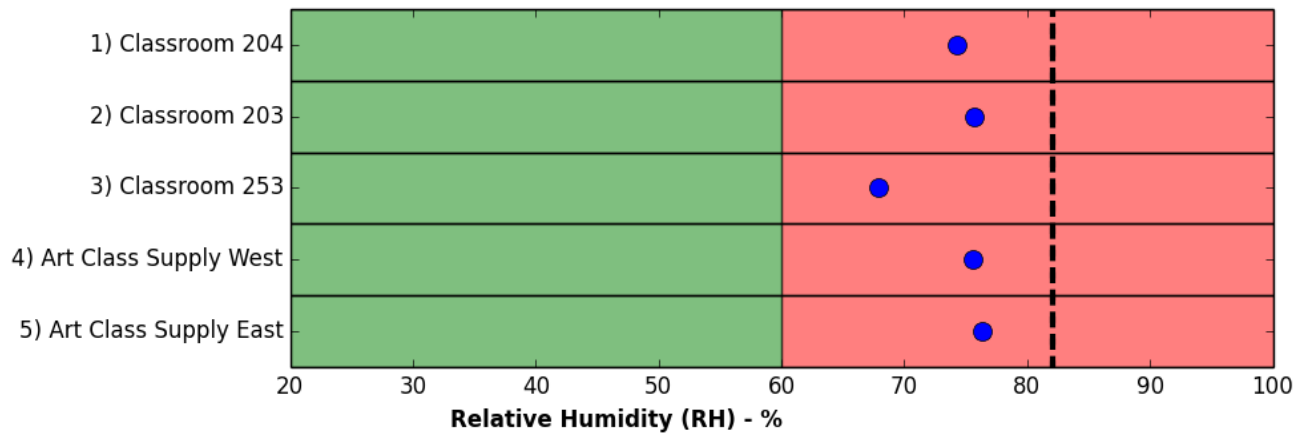
ASHRAE recommends that relative humidity levels within a building served by mechanical systems should be less than 65%. Levels above 70% are particularly conducive to fungal growth, while maintenance of humidity levels between 20% - 60% effectively inhibits growth.

Relative humidity in each test area exceeded recommended levels.

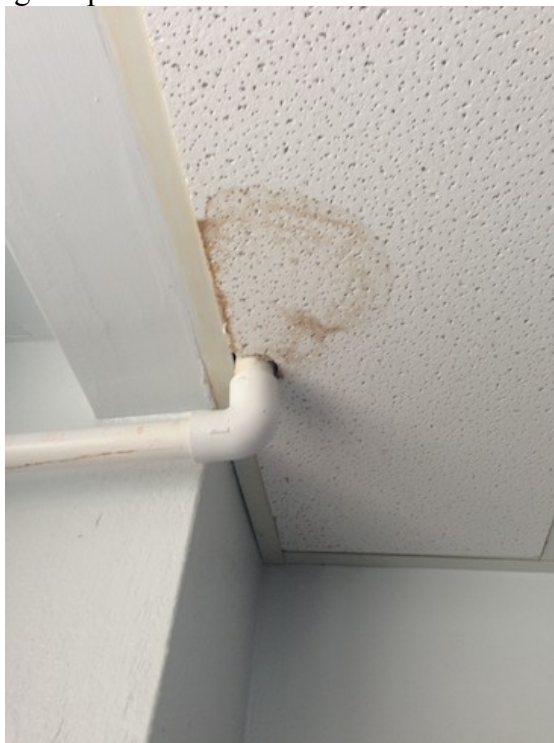
- Water damaged ceiling tile present (Photo 1)
- Classroom 203:
  - Ceiling A/C unit is present, but no climate control at time of testing
    - Dust and / or fungal contamination present A/C vent (Photo 2)

Photo 1: Water damaged ceiling tile present in Classroom 204

- An assessment of the ceiling space above Classroom 204 should be carried out to ascertain whether water damage has taken place leading to the growth of mould on surfaces.

- All water damaged ceiling tiles, and those immediately adjacent, should be removed and replaced.
- The cabinetry in Classroom 203 should be wiped down to remove surface contaminants.

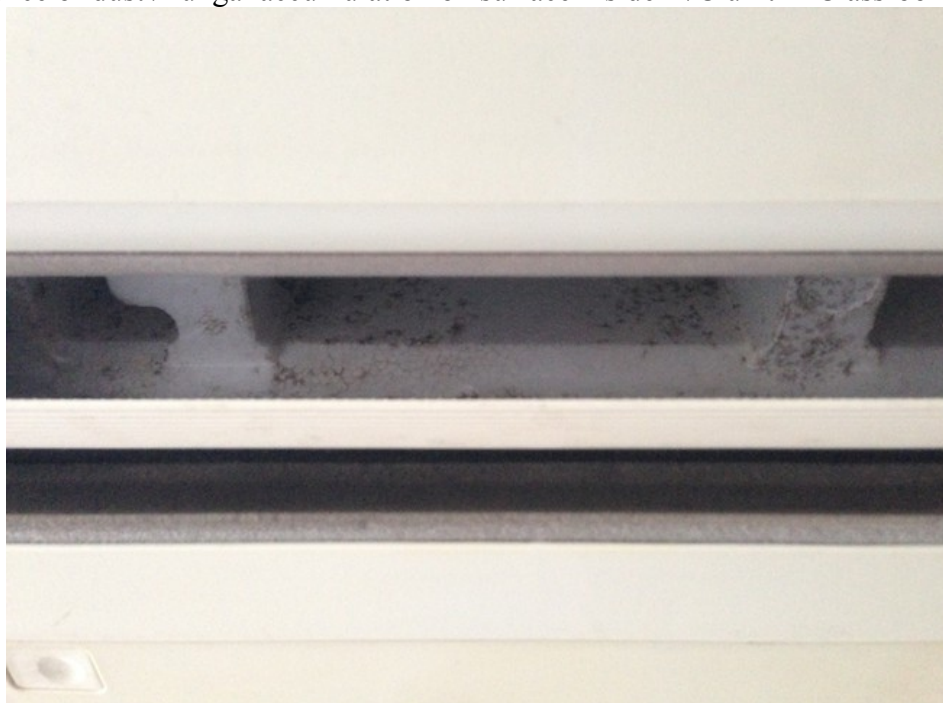
Photo 2: Evidence of dust / fungal accumulation on surface inside A/C unit in Classroom 203

- Servicing of the A/C's should take place on a regular basis. This should include addressing any areas of condensation leading to leaks and resulting staining on walls, or water damaged ceiling tiles.

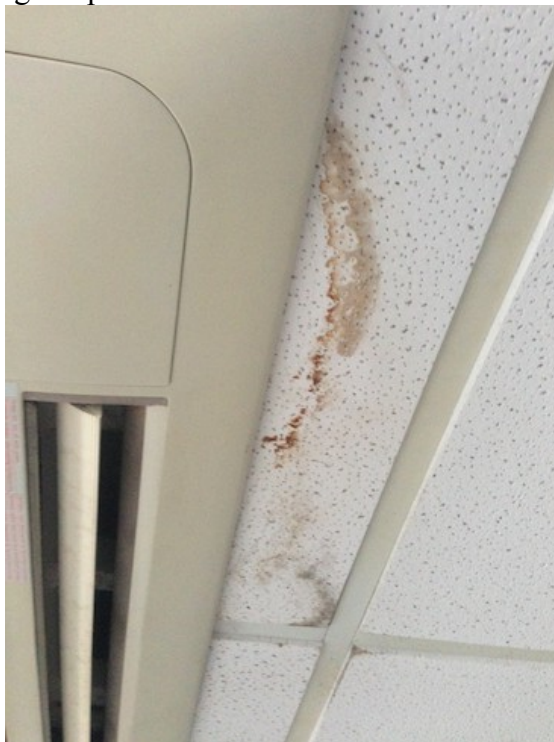
- Water damaged ceiling tile present (Photo 3)
  - Evidence of previous water damage present on walls (Photo 4)
  - Evidence of possible fungal growth present in cabinetry (Photo 5)

Photo 3: Water damaged ceiling tile present in Classroom 203

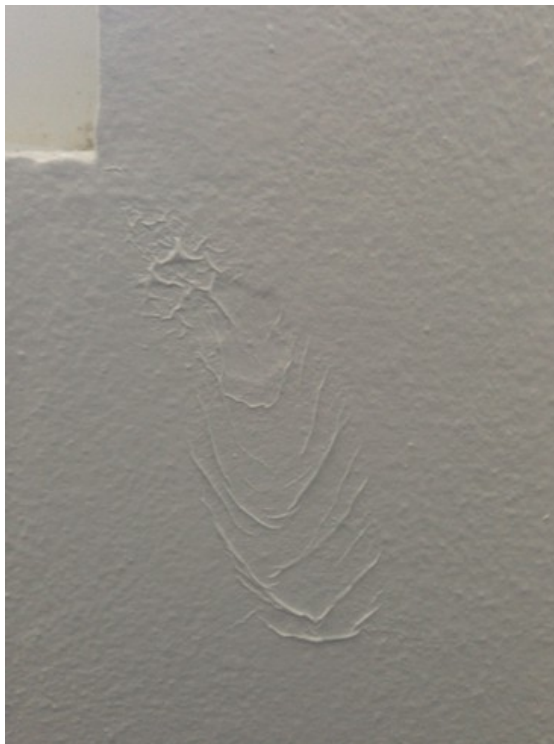
Photo 4: Evidence of previous water bubble on wall in Classroom 203

- If any areas of bubbling paint on walls inside become apparent, they should be addressed as follows:
  - Vacuum affected areas with a HEPA vacuum to remove any loose dust or paint

- Scrape walls to remove remaining bubbling paint
  - Wipe walls down with a detergent solution and run dehumidifier to allow drying and to draw any moisture from within the wall.

- Wall can be painted once wet wiping treatment has dried.

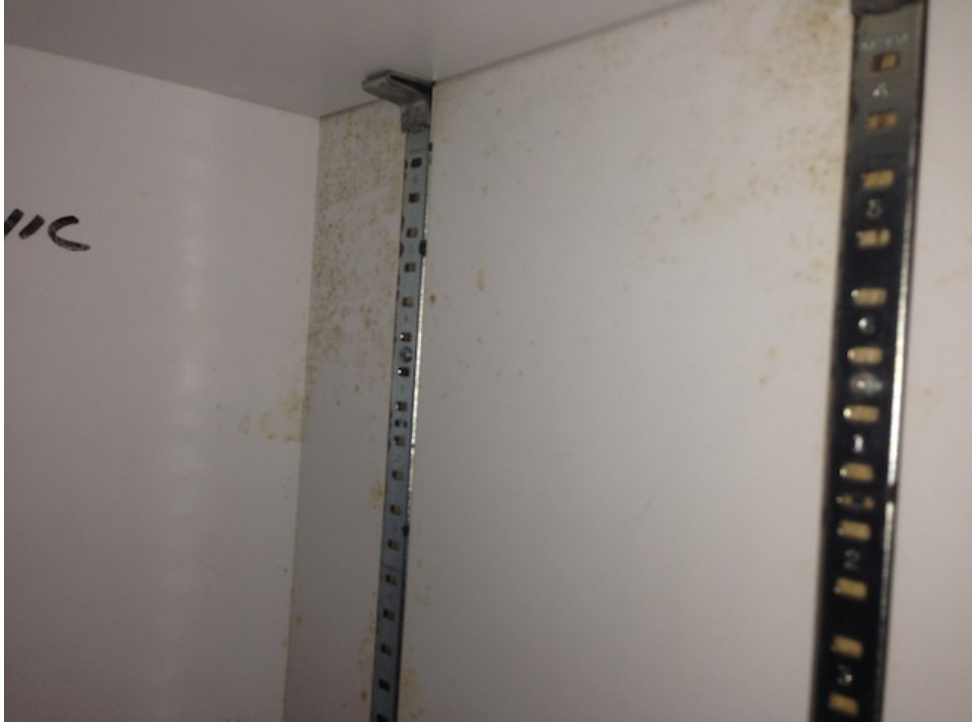
Photo 5: Evidence of possible fungal growth in Classroom 203 cupboard

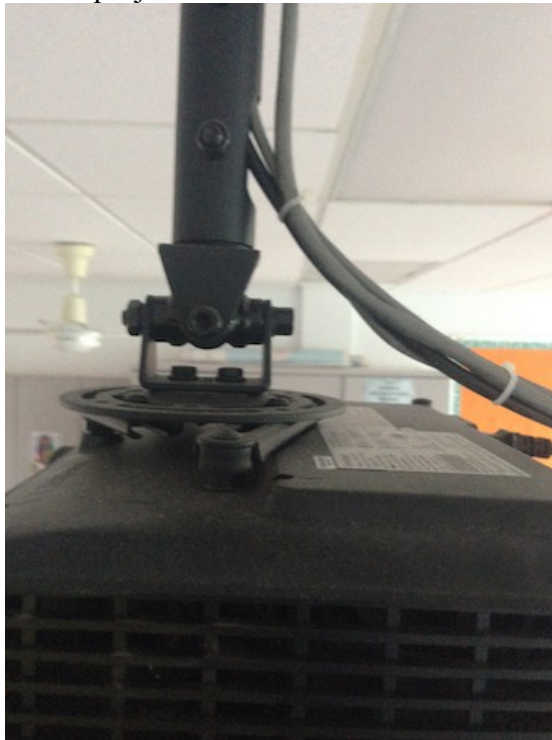
- Classroom 253:
  - Evidence of minor dust build-up present on upper surfaces (Photo 6)
  - Standing air-conditioner / dehumidifier operational at time of testing

Photo 6: Dust build-up on surface of projector in Classroom 253

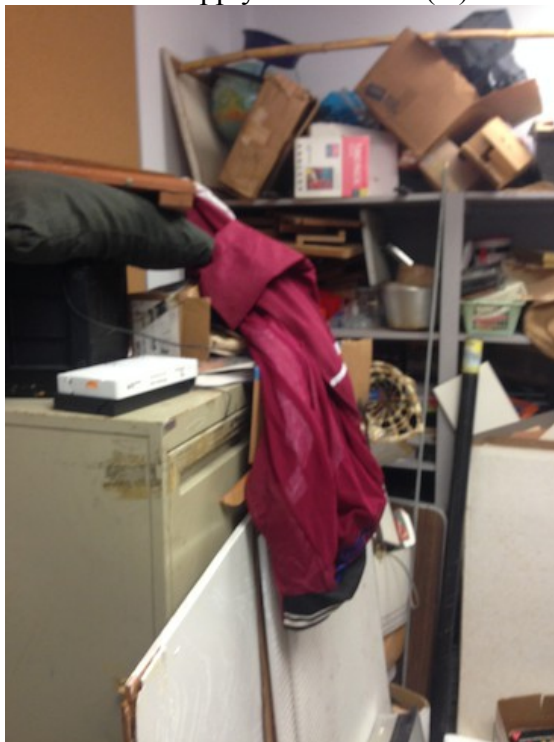
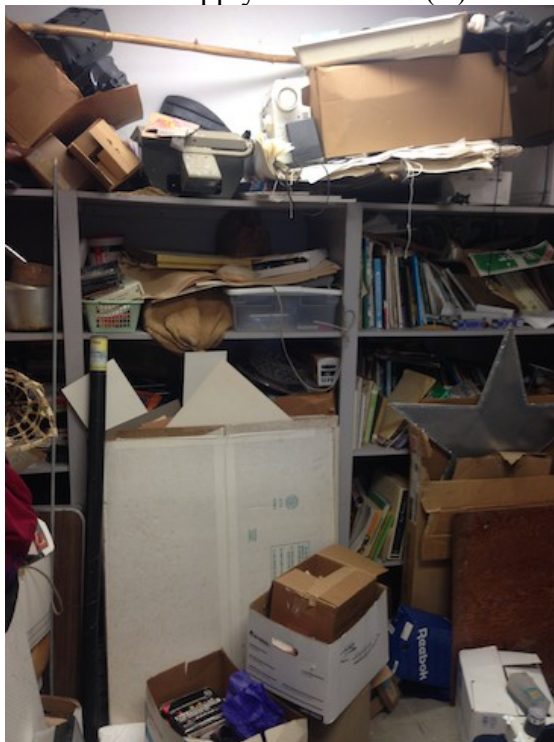
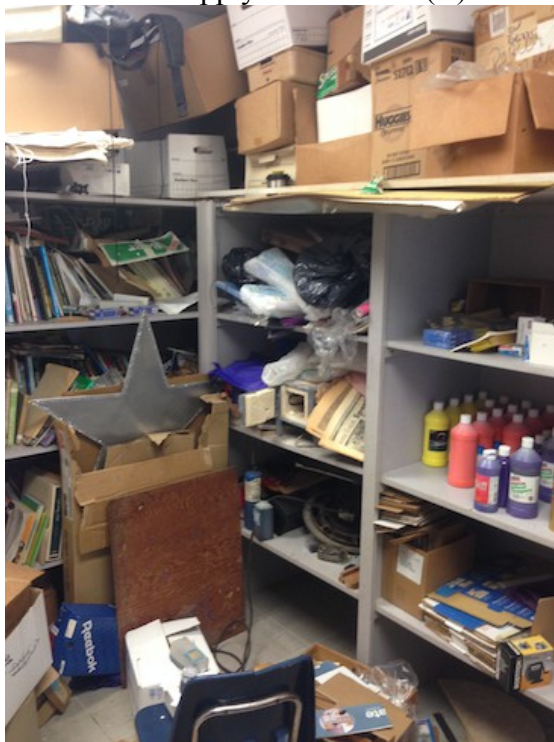
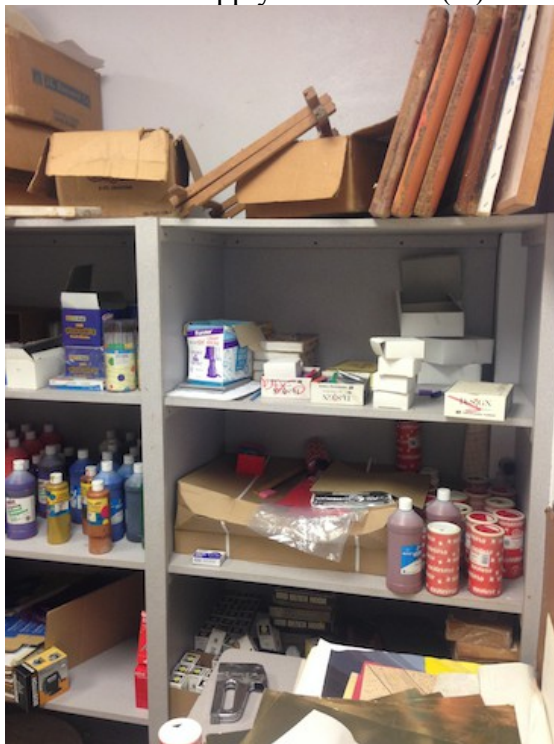
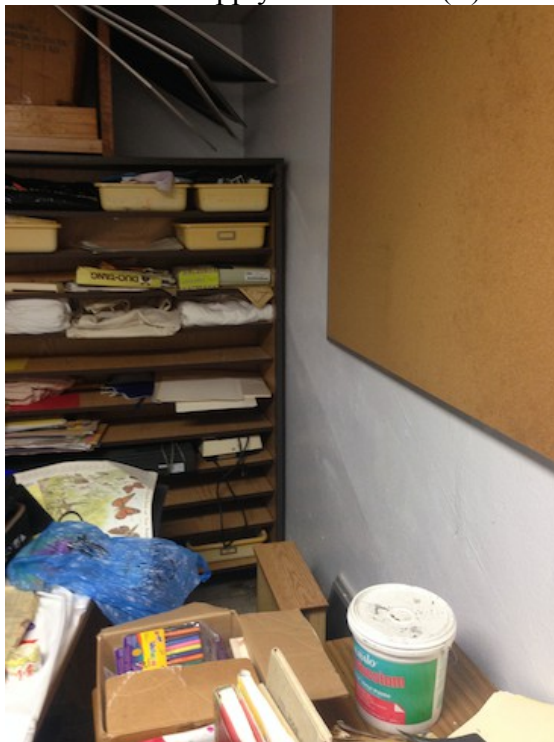
- Both exhaust fans showed heavy dust build-up
  - Each room contained large amounts of stored materials with evidence of fungal growth (Photos 7 - 16)

Photo 7: Supplies stored in Art Classroom Supply Room West (A)

- The Art Supply Rooms should be emptied and all surfaces cleaned. Any materials being stored showing evidence of possible fungal growth should be discarded and replaced as necessary.

- Due to the levels and types of moulds observed in the air and on surfaces in the Art Supply Rooms, consideration should be given to contracting Government approved mould remediation contractors to carry out this work. This will ensure that efforts are made to prevent cross-contamination to adjacent areas, in addition to the use of proper PPE for personal protection of workers and school occupants.

- Plastic containers should be used to store materials in the Art Supply Rooms as these are easily wipeable and not porous. Ideally, materials should be stored in a way that allows air movement.

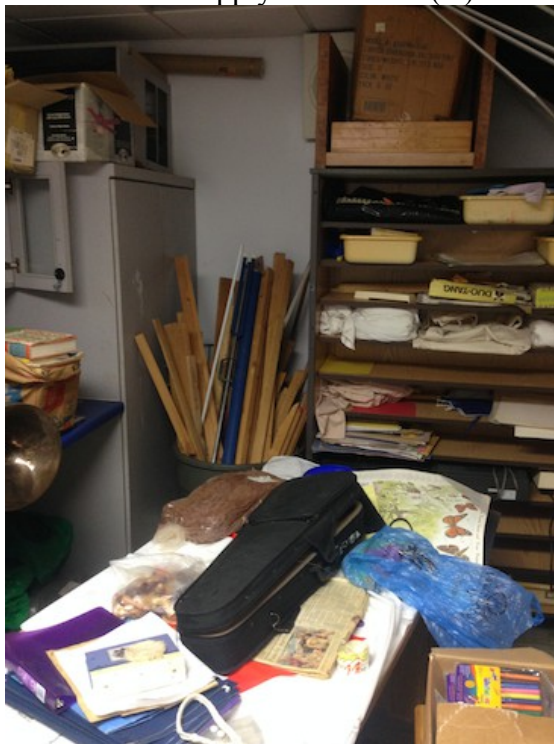
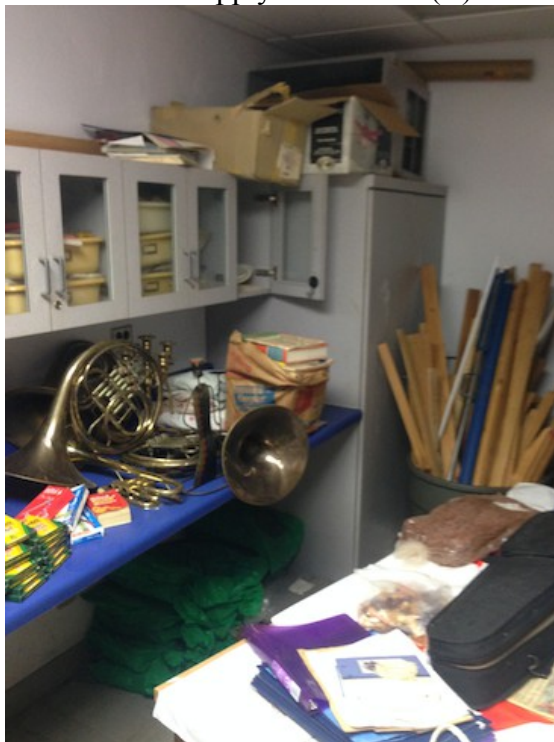
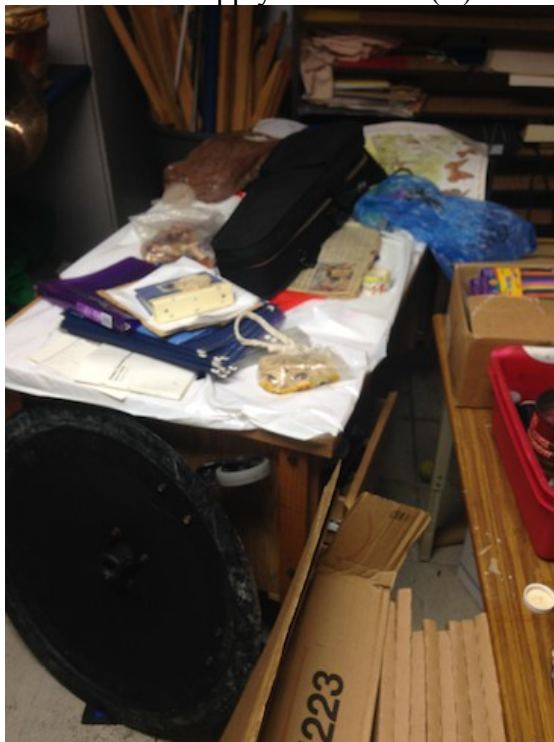
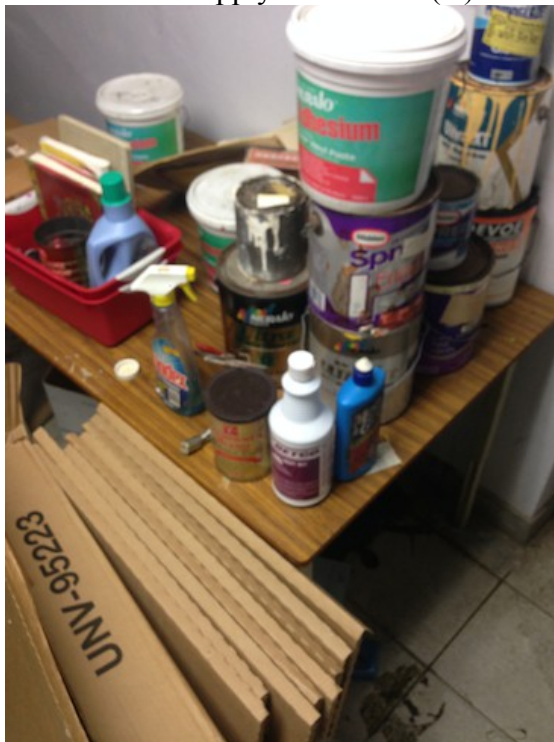
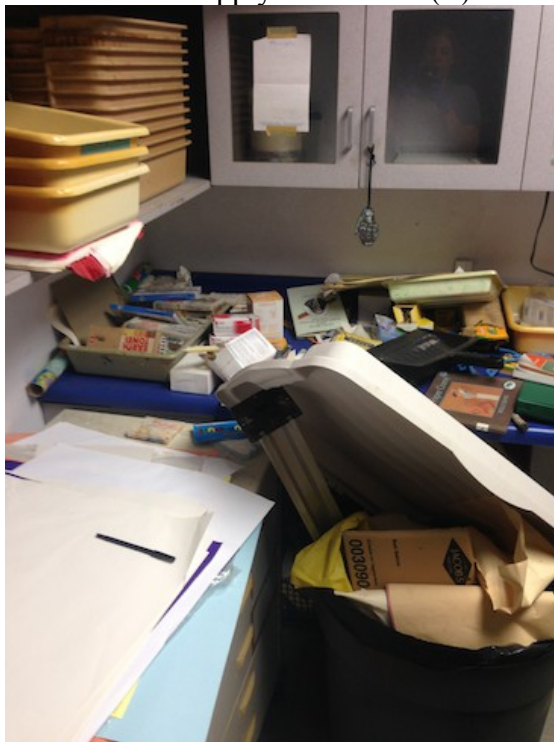
Photo 12: Supplies stored in Art Classroom Supply Room East (A)

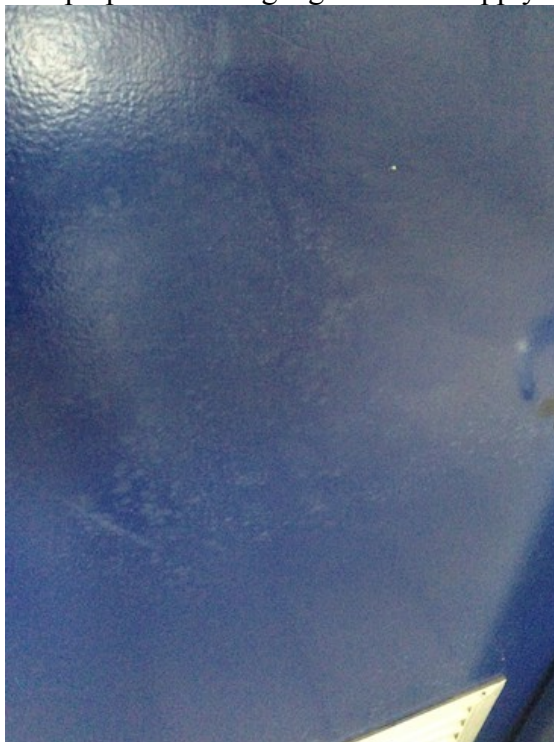
- The outside of each door showed discolouration consistent with possible fungal growth (Photos 17 & 18)
  - Heavy dust build-up, including insects and insect fragments, was present on surfaces and floors in each room

Photo 17: Evidence of dust build-up / possible fungal growth on Supply Room West door

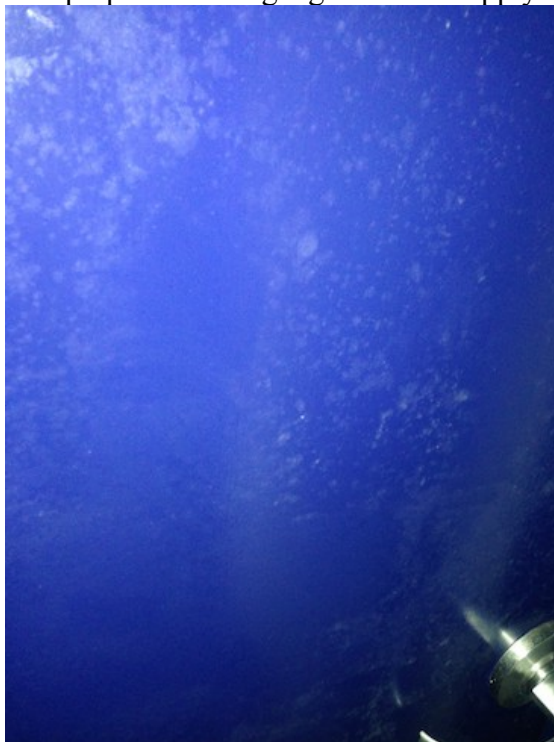
Photo 18: Evidence of dust build-up / possible fungal growth on Supply Room East door
