ACCIDENT

Aircraft Type and Registration:	Cessna 172M Skyhawk II, N9085H	
No & Type of Engines:	1 Technify Motors TAE 125-02-114 turbocharged diesel piston engine	
Year of Manufacture:	1975 (Serial no: 17265932)	
Date & Time (UTC):	30 April 2018 at 2045 hrs	
Location:	Bermuda Airport, Bermuda	
Type of Flight:	Private	
Persons on Board:	Crew - 1	Passengers - None
Injuries:	Crew - Minor	Passengers - N/A
Nature of Damage:	Aircraft damaged beyond economic repair	
Commander's Licence:	FAA Commercial Pilot's Certificate	
Commander's Age:	36 years	
Commander's Flying Experience:	878.6 hours (of which 748.6 were on type) Last 90 days - 0 hours Last 28 days - 0 hours	
Information Source:	AAIB Field Investigation

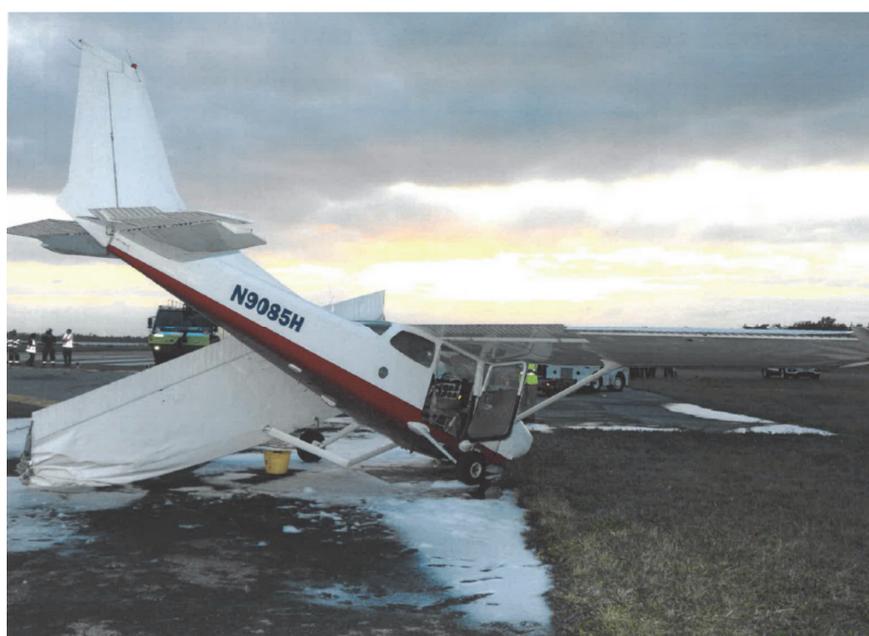
Figure 1

Image of the aircraft taken shortly after the accident

Given the pilot's report, the investigation focussed on the aircraft's flying controls. No defects were found within the aileron, rudder or elevator control circuits or the range and freedom of control surface movement. Photographs of the aircraft, taken immediately after the accident (Figure 1) showed the elevator trim tab in a position which corresponded to a NOSE DOWN trim position. Operation of the elevator trim system showed that the elevator trim tab moved in the opposite sense to the movement of the elevator trim wheel in the cockpit, with movement of the trim wheel to increase NOSE UP trim resulting in movement of the trim tab to increase the aircraft's tendency to pitch NOSE DOWN. Detailed examination of the aircraft, carried out by the BCAA and the operator, confirmed that the trim tab drive chain was engaged on the actuator drive sprocket and that the chain guard was correctly fitted. Further examination showed that the elevator trim system cables were correctly routed through the fuselage but the section of the cables and chain in the horizontal stabiliser had been rotated through 180°, crossing the cables and drive chain. This resulted in the trim tab moving in the opposite sense to that commanded by the trim wheel input.

The investigation confirmed that the elevator trim system had been rigged incorrectly, resulting in movement of the elevator trim tab in the opposite sense to the pilot's control inputs. The cables and drive chain which operated the trim tab actuator were rotated by 180° from their normal position within the horizontal stabiliser, reversing the movement of the trim tab. The presence of the elevator trim tab actuator chain guard, and the fact that the drive chain was still engaged on the actuator drive sprocket, confirmed that the actuator drive system had been assembled incorrectly during the maintenance input prior to the accident flight.

The Bermuda-based maintenance organisation has introduced procedures to ensure that duplicate inspections of all flight critical systems are carried out, in line with its BCAA-approved maintenance procedures, on any aircraft that they operate or maintain, regardless of its State of Registration.

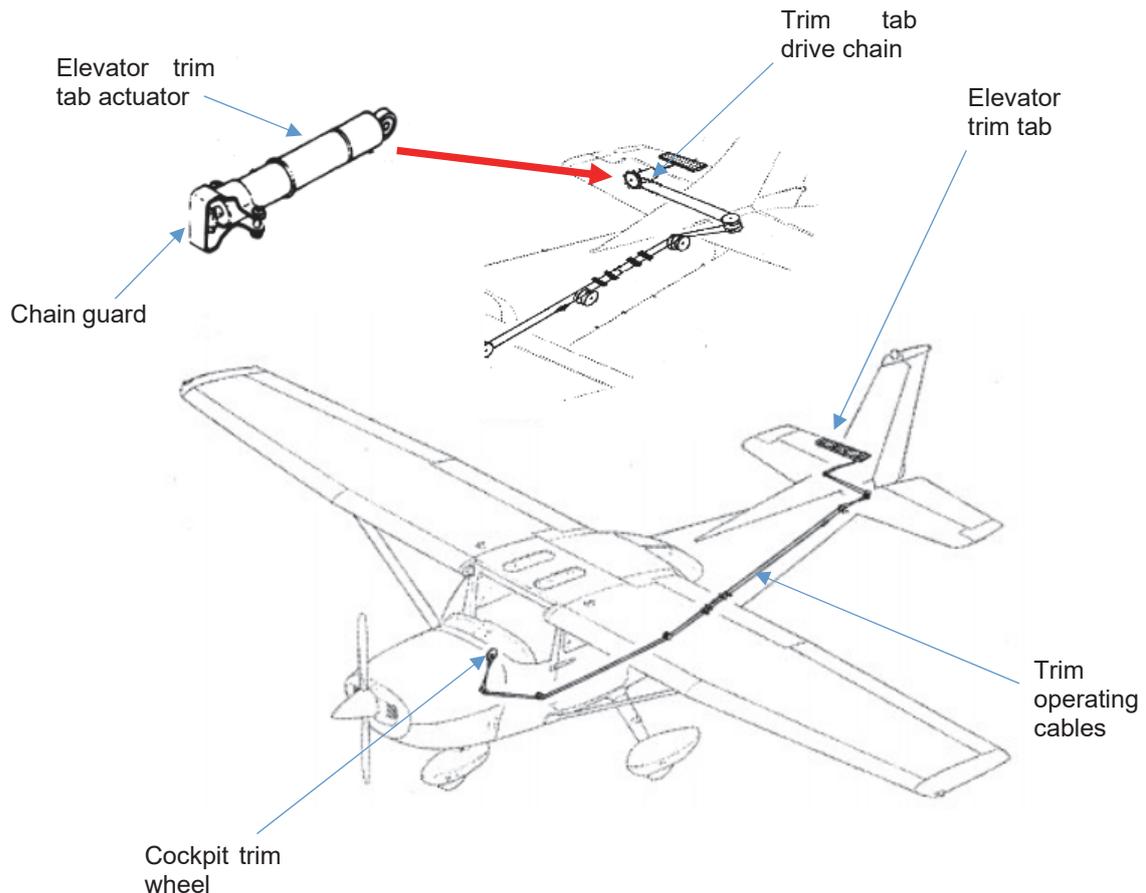
Figure 2

The Cessna 172 is fitted with a moveable trim tab on the right elevator. The trim tab is used to 'trim' the aircraft and allow it to be flown at various attitudes with minimal pilot control force. The elevator trim system consists of a cockpit-mounted wheel and position indicator connected to a pair of cables which extend, through a series of pulleys, to the elevator trim tab actuator (Figure 2). The two cables are connected at the elevator by a length of chain which is looped around a sprocket on the trim tab actuator. A chain guard ensures that the chain remains engaged with the sprocket.

Rotation of the trim wheel moves the drive chain on the actuator sprocket, extending or retracting the actuator which in turn moves the trim tab. When the cockpit control wheel is turned, the position indicator moves to indicate the direction of trim wheel movement, either NOSE UP or NOSE DOWN. Movement of the trim wheel in a NOSE UP direction results in the elevator trim tab moving downwards in relation to the elevator and movement of the trim wheel in a NOSE DOWN direction results in the elevator trim tab moving up. Prior to takeoff, to ensure that adequate pitch control is available, the elevator trim tab is set to the neutral position, identified by the TAKEOFF position marked on the trim position indicator.

Cessna 172 pitch trim system
